**ANALYSIS OF DAMAGE TO A EUROCOPTER AS350-B2 HELICOPTER
NTSB ID ANC08FA053**

Aircraft: Eurocopter AS 350-B2, S/N 3158
Registration: N213EH
Date: April 15, 2008
Location: Sheep Mountain, Alaska
Operator: ERA Helicopters Inc.
NTSB ID: ANC08FA053

ANALYSIS OF DAMAGE TO A EUROCOPTER AS350-B2 HELICOPTER

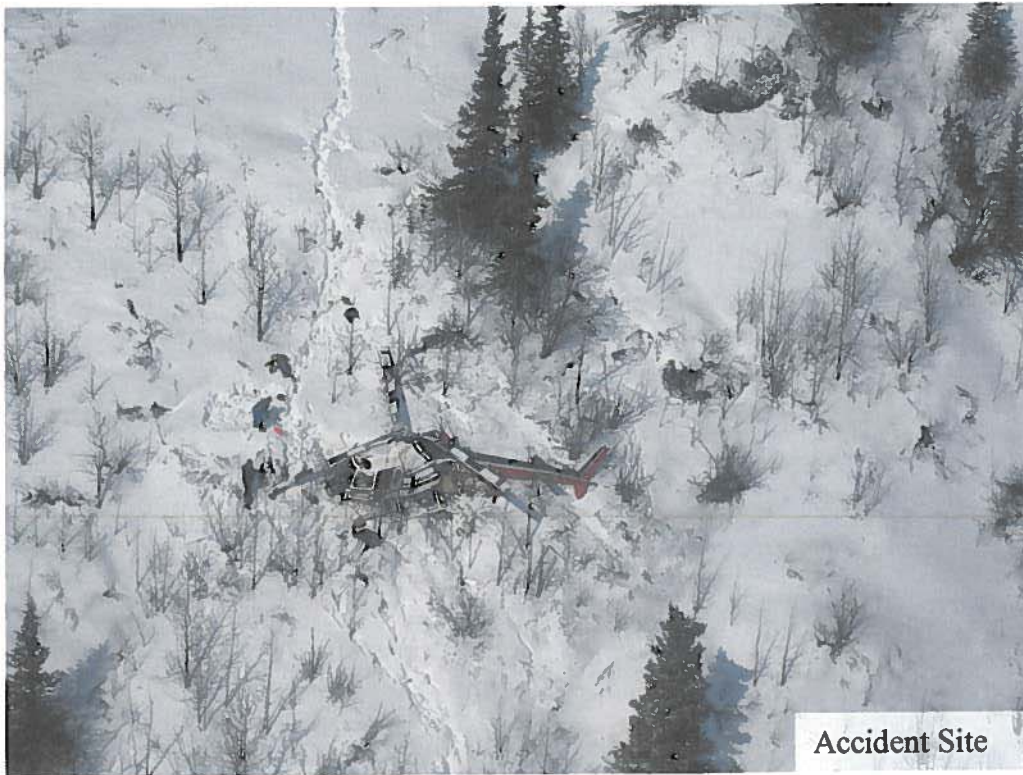
Figure 1 shows an aerial view of the helicopter at the accident site below the ridge of the ravine. The helicopter impacted the sloping terrain with a substantial vertical descent and remained in a level attitude. The fuselage damage from the impact was mostly on the right side. The right skid separated from the helicopter and was located on the down sloping terrain to the left of the helicopter. The left skid was partially suspended in air away from the slope (Figure 2). Small trees adjacent to the left side of the helicopter were broken indicating some movement to the right during the impact with the slope. The main gearbox (transmission) was tilted toward the slope. The forward end of the tail boom was buckled in a downward direction indicating a substantial vertical descent during ground impact (Figures 2 and 3). The blue main rotor blade exhibited damage on the trailing edge during the vertical descent through the brush (Figure 4). The willow brush around the helicopter at the crash site was not cut by the main rotor blades indicating lack of significant rotor speed during ground impact (Figures 4 and 5). The tail rotor blades mostly were covered with snow (Figure 6).

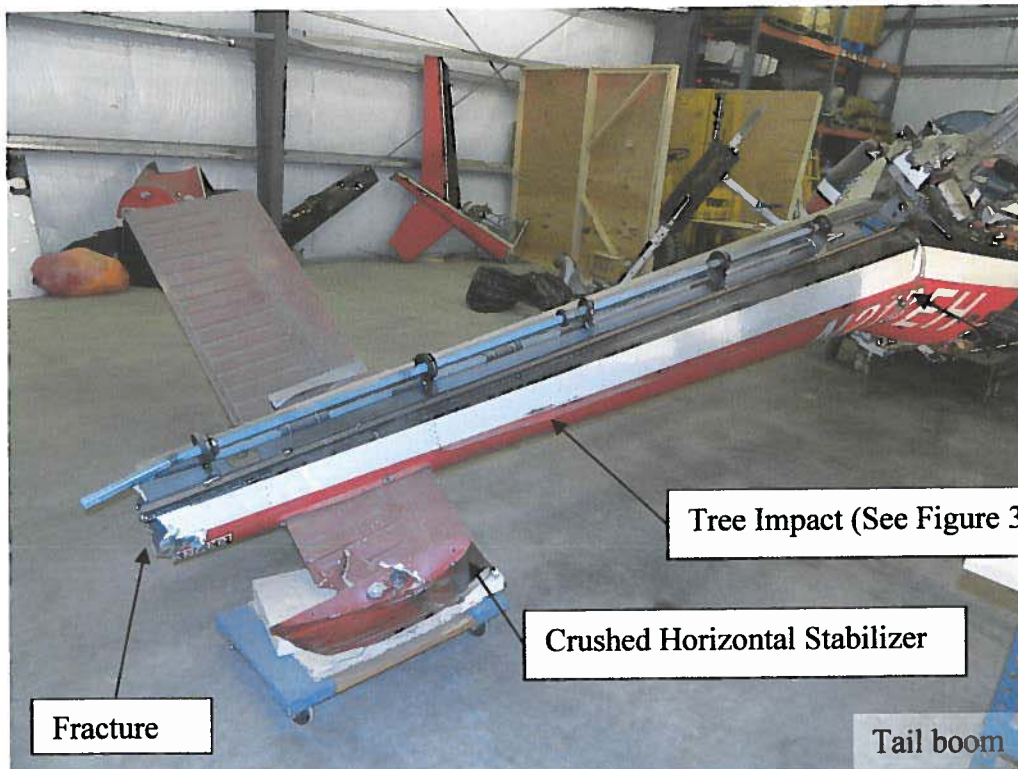
Accident scene photographs show downward deformation at the forward end of the tail boom and tearing of the tail boom aft of the horizontal stabilizer. Figure 17 shows the tail boom during the inspection. The end of the right horizontal stabilizer was crushed during impact with the sloping terrain. The right side of the boom and TR driveshaft cowling exhibited deformation and embedded wood from impact with a tree (Figures 37, 38 and 39). A small broken tree was located adjacent to the left side of the tail boom near the deformed area. The TR driveshaft and cowling were not impacted by a rotating MR blade during the vertical descent at the final crash site, further indicating lack of significant rotor speed.

Buckle

Tree Impact (See Figure 37)

Crushed Horizontal Stabilizer

Fracture

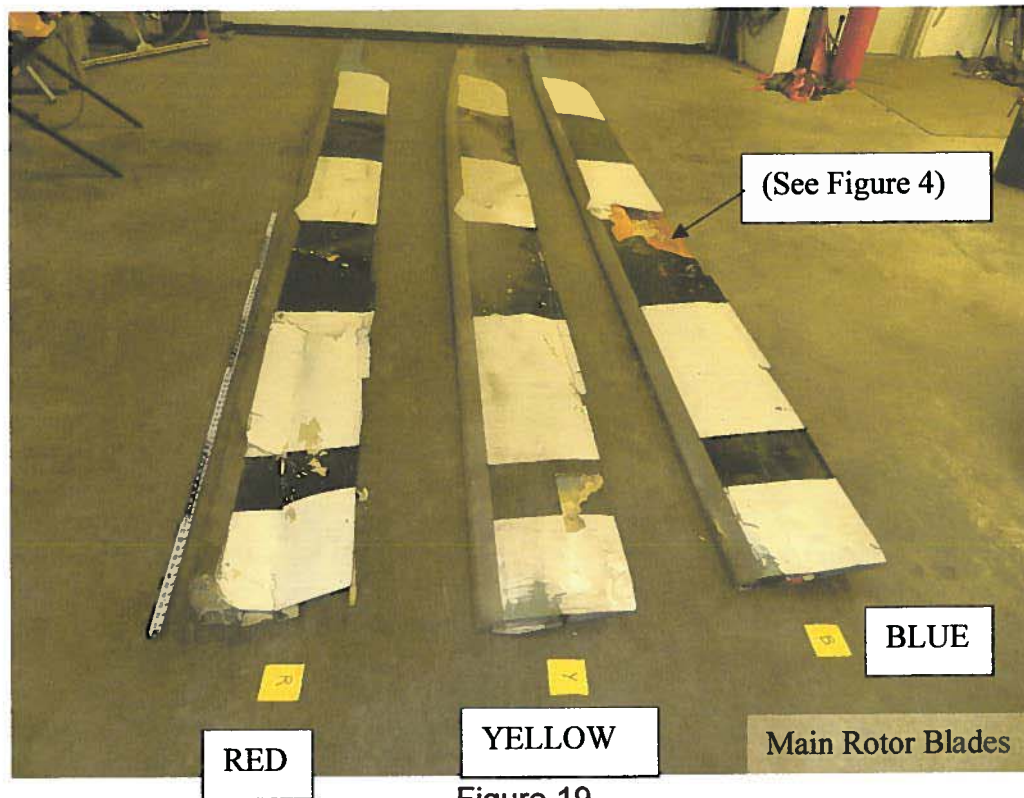
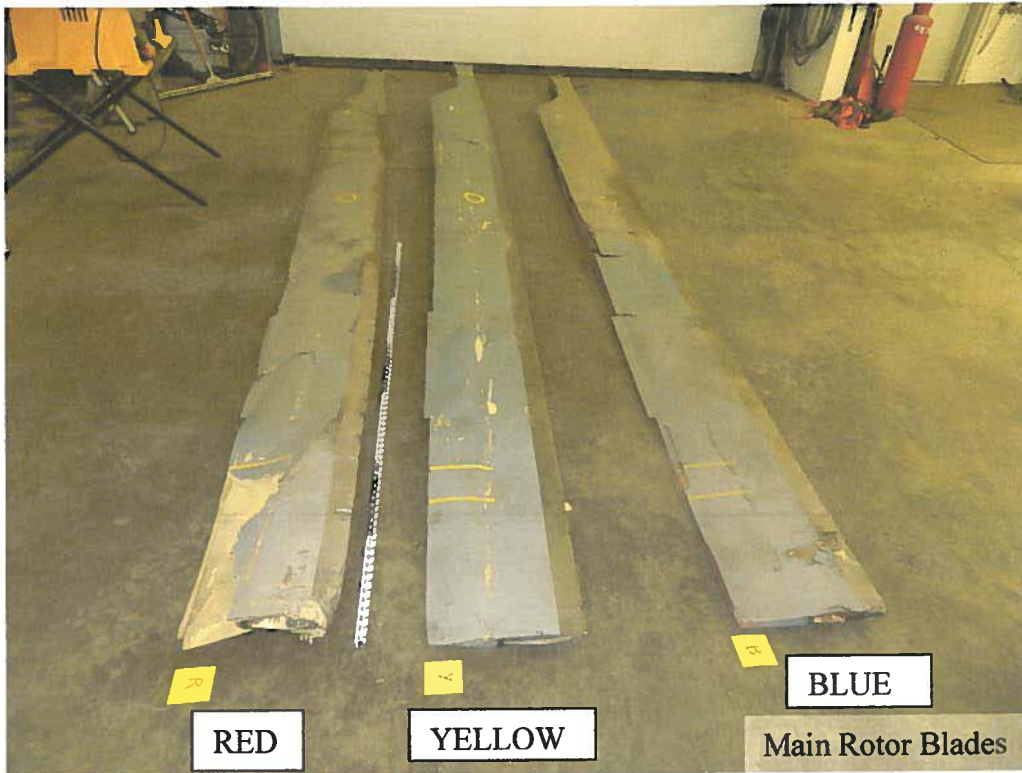
The AS350 helicopter has three main rotor blades that are color coded red, yellow, and blue. When viewed from above the blades rotate in a clockwise direction. Figures 19 and 20 show the MR blades during the inspection on September 11, 2012. All three blades exhibited impact damage to the leading edge, skin tearing, buckling, and separation (splitting) at the trailing edge (Figure 21). The outboard end of the red blade exhibited chordwise bending and was shattered. The abrasion strip was deformed and the tracking finger separated (Figures 22 and 23). The stainless steel leading edge abrasion strip exhibited multiple dents and chordwise abrasions caused by impact with the terrain while the blade was rotating at a significant speed. The yellow blade also exhibited chordwise bending, leading edge dents, and chordwise abrasions (Figures 24 and 25). The blue blade exhibited damage similar to the red blade but to a lesser extent (Figures 26 and 27). All three blades exhibited damage caused by impact with the terrain while at a significant rotational speed. This damage occurred prior to the final impact at the crash site as indicated by the lack of rotor speed when the helicopter impacted the sloping terrain.

1. All three main rotor blades exhibit damage caused during impact with the terrain while at significant rotational speed (Figures 19 through 27). This damage occurred prior to final impact at the crash site as indicated by the lack of rotational damage to the willow brush surrounding the helicopter at the final resting place (Figures 2 through 6).

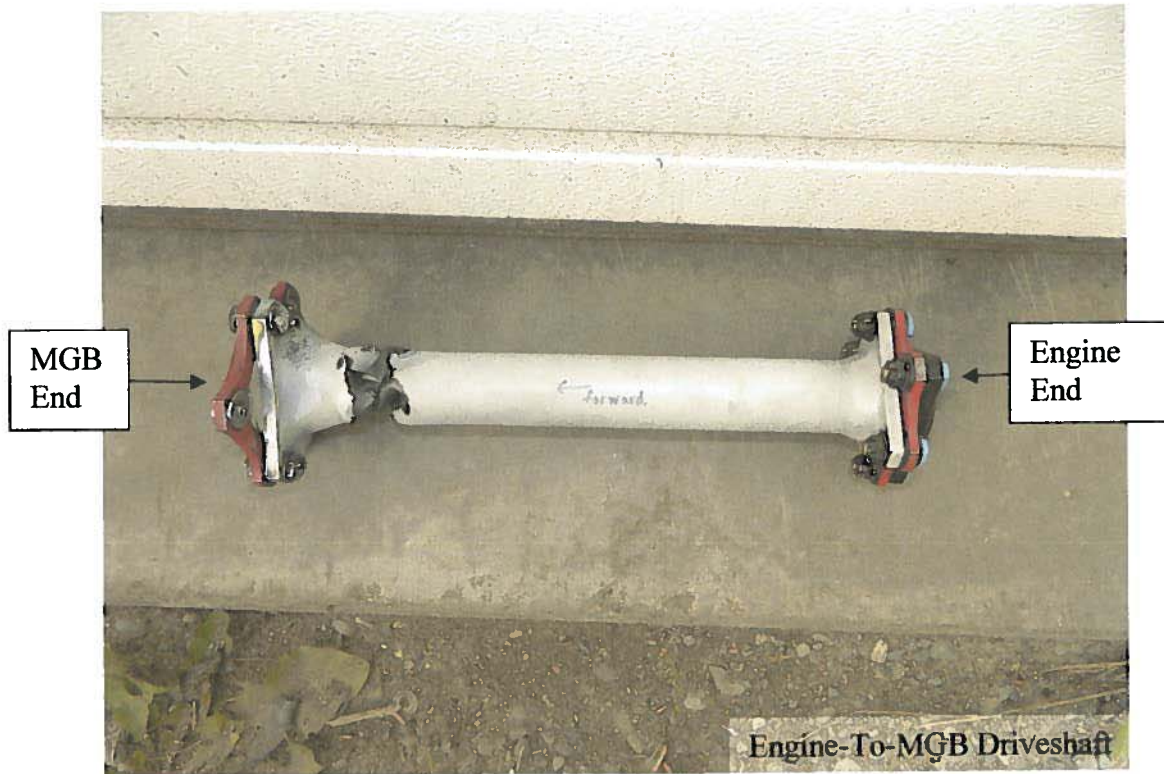
coupling at the forward end. Figure 32 shows the driveshaft between the engine and MGB during the September 11, 2012 inspection. The flex couplings at both ends were intact. The shaft has a rotational twist and partial fracture (Figure 33). Engineering analysis performed by Eurocopter indicates that torsional deformation to the shaft requires an overload torque in excess of 300 percent. The driveshaft rotates clockwise when viewed from the engine. The direction of twist (torsional buckles) in the driveshaft indicates that the engine was driving the shaft when the forward end at the MGB encountered a severe resistance. The severe resistance caused the engine to overload the driveshaft resulting in torsional deformation. The severe resistance was produced during impact of the MR blades with the terrain. Impact of the MR blades with terrain occurred prior to the final crash site impact and caused a substantial resistance to rotation of the blades and MGB. The engine was providing rotational power to the driveshaft at the aft end while the forward end was encountering substantial resistance during MR blade impact. The result was a twisted shaft. The twisting deformation caused the overall length of the driveshaft to shorten. The measured length of the twisted shaft was 32.2 cm, compared to the manufactured length of 34.1 cm. Shortening of the shaft by approximately 1.9 cm caused the spline coupling at the aft end of the driveshaft (Figures 34 and 35) to nearly separate from the mating splines on the power shaft assembly (Figure 36). An overlap of approximately 3.5 mm existed between the mating splines. Continued rotation of the engine power shaft caused rotational smearing at the ends of the mating splines (Figures 35 and 36) and disengagement of the driveshaft. The splines on the coupling for the engine power shaft assembly and on the driveshaft spline coupling were both damaged resulting in loss of drive to the MGB and MR blades. The coupling tube surrounding the driveshaft exhibited a small area of deformation.

Loss of drive to the MR blades occurred due to the torsional deformation to the engine-to-MGB driveshaft. The driveshaft deformation occurred due to impact of the main rotor blades with terrain while being driven by the engine. The driveshaft deformation must have occurred after departure and near the crash site in order to lose MR blade rotation at the final crash site. Impact of the MR blades also caused deformation to the muff coupling and over rotation of the drive retaining nut. Loss of the driveshaft to the MGB caused the engine to over speed and resulted in shedding of the PT blades. The engine was not likely to have been running under any power at the crash site. Downward deformation of the boom caused the TR driveshaft to decouple at the aft end of the forward steel shaft. Continued residual rotation of the steel shaft segment connected to the engine power shaft caused rotational damage to the driveshaft coupling and inner surface of the cowling.

2. The twisted engine-to-MGB driveshaft (Figure 32), over-rotated module No. 5 drive retaining nut (Figure 60), and deformed muff coupling (Figure 61) all indicate significant engine power applied to the engine gearbox and driveshaft when a substantial resistance was encountered. Damage to the main rotor blades is the only indication of a substantial resistance that would explain the shaft and coupling deformation and nut over-rotation. The main rotor damage occurred during flight and prior to the final crash site.

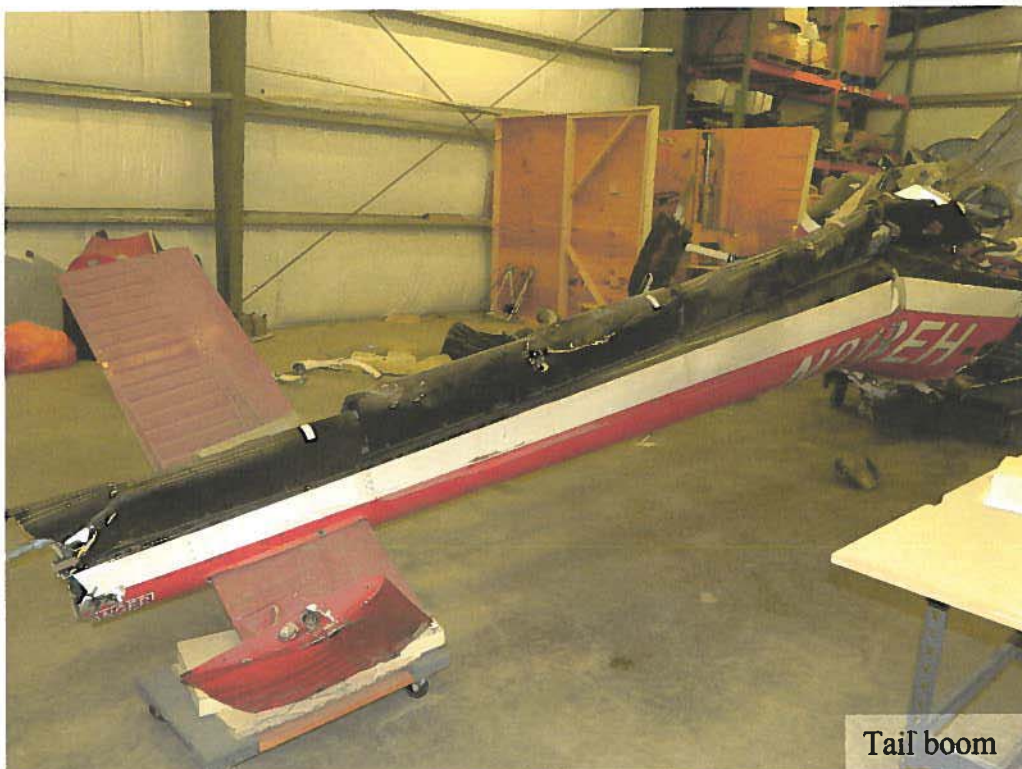
cowling. Figure 40 shows the tail boom with the driveshaft cowling (painted black) in place. The forward end of the tail boom was severely buckled due to the downward collision forces. The downward deflection caused the TR driveshaft to separate at the spline connection at the aft end of the steel section of the driveshaft.

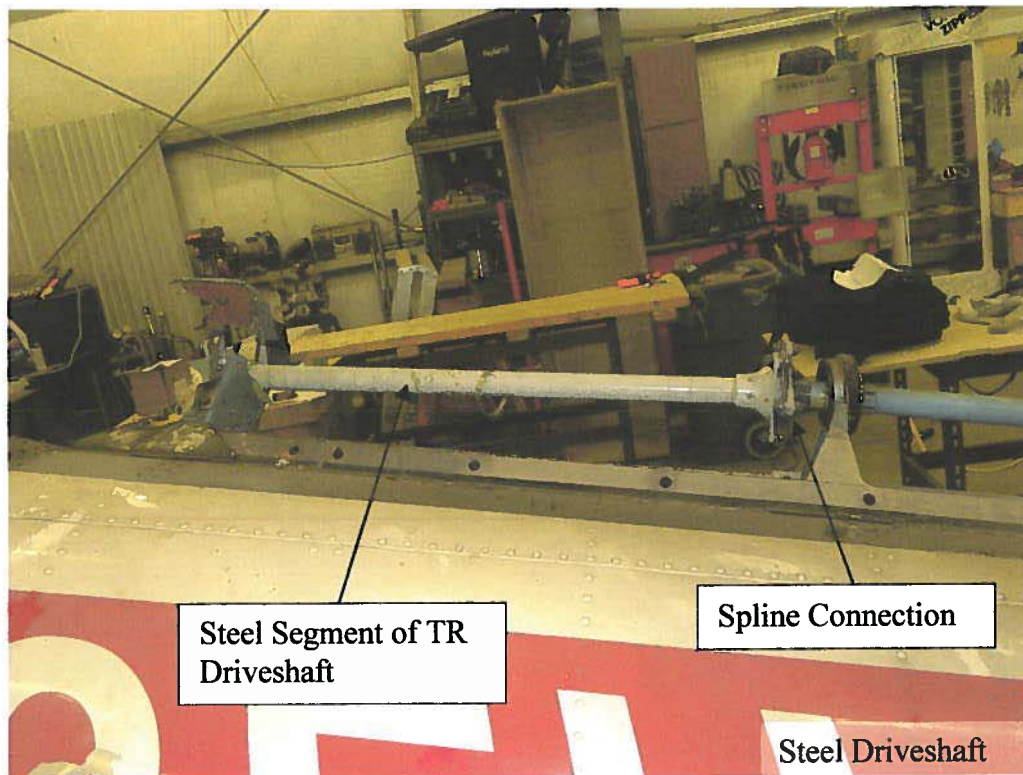
Figure 41 shows the forward (steel) segment of the TR driveshaft after being repositioned on the tail boom. The flex coupling at the forward end of the steel shaft (Figure 42) connects to the engine TR drive output. The flex coupling was fractured due to overload forces. The aft end of the steel driveshaft is shown in Figure 43. The flex coupling and splines are intact. The outer edges of the aft flex coupling exhibit light deformation from contact during rotation with the TR driveshaft cowling (Figure 44). Mating rotational scoring was present on the inner surface of the cowling (Figure 45). The rotational damage indicates that the TR driveshaft had some residual rotation during impact with the terrain at the final crash site. The vertical impact forces caused the tail boom to deform downward and the steel section of the driveshaft to separate at the spline connection with the aluminum shaft. Continued rotation of the driveshaft caused the rotational damage to the flex coupling and cowling. The forward flex coupling fractured due to overload forces after separation at the spline connection and deflection of the driveshaft.

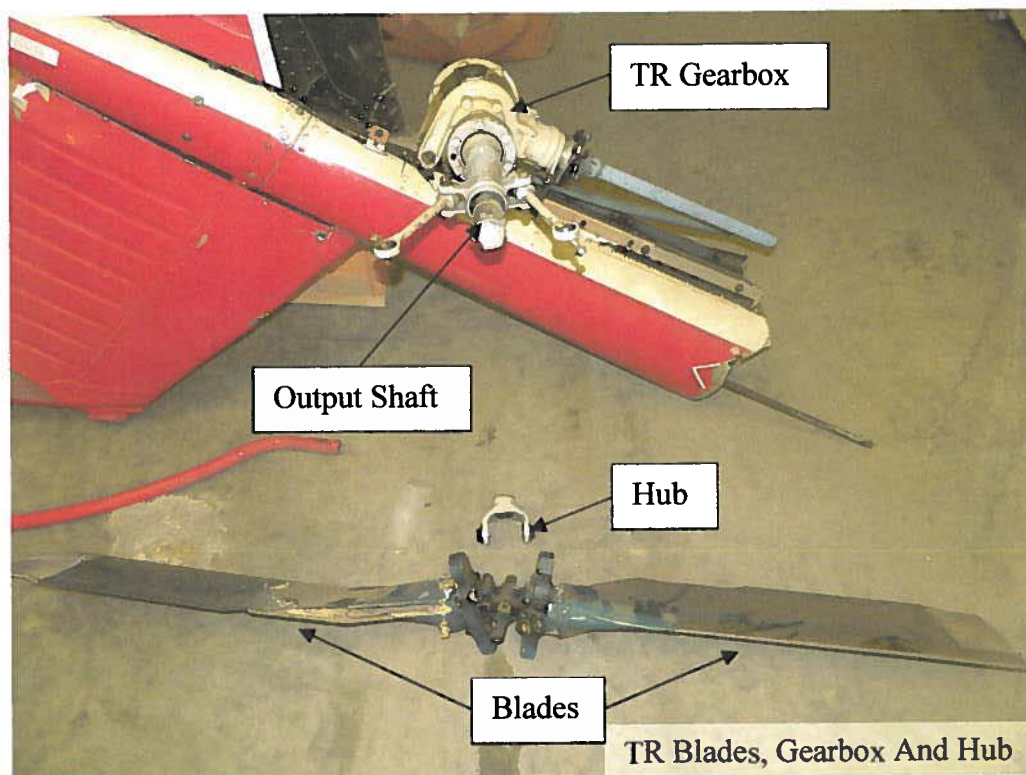
Figure 46 shows the TR blades adjacent to the aft section of the tail boom. The fiberglass in both blades was shattered due to impact forces. The strike tabs on both blades were bent opposite to the direction of rotation (Figures 47 and 48). The leading edge abrasion strip on one blade was dented due to contact with the terrain during blade rotation (Figure 47). Both blades exhibit chordwise abrasions. The blades also exhibit contact marks from flapping.

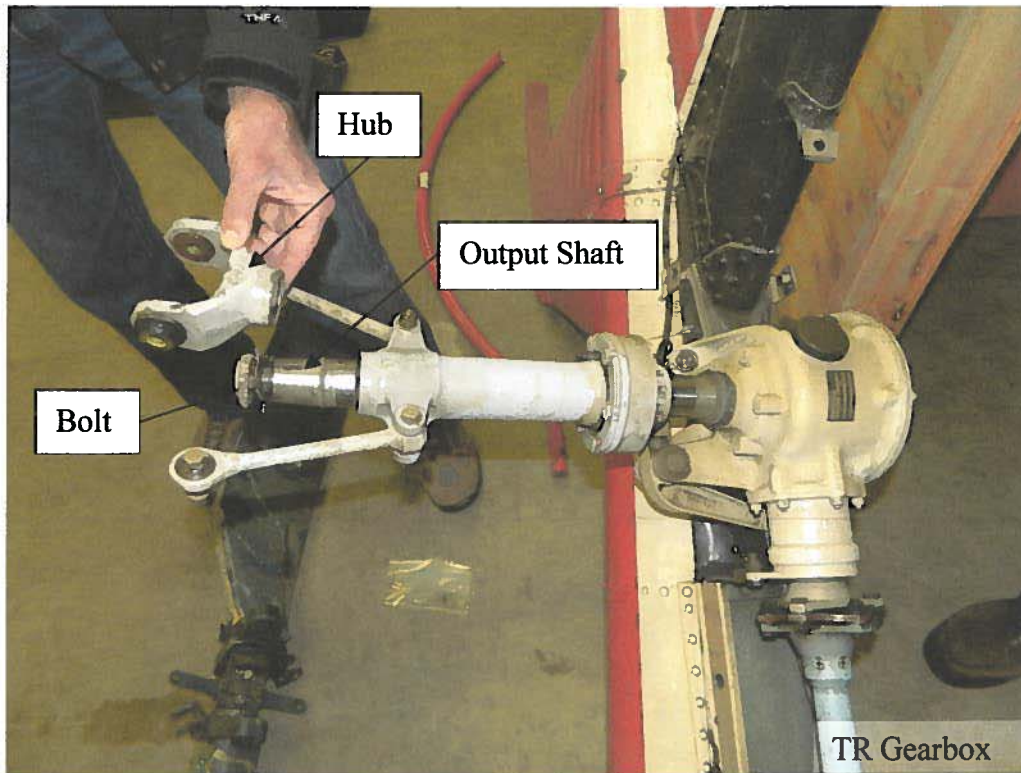
Figure 49

The tail rotor gearbox rotated freely. The aluminum driveshaft and pitch control tube were cut previously. The TR hub is installed on the gearbox output shaft and secured with a bolt and key (Figure 49). The key between the output shaft and hub had sheared due to overload forces (Figures 50 and 51). The output shaft rotates counter-clockwise when viewed from the end of the shaft. The direction of shear on the fractured key was opposite to the direction of shaft rotation. Either there was a significant acceleration of the output shaft caused by suddenly available engine power when the MR blades contacted the ground and the engine-to-MGB driveshaft separated, or the TR blades impacted the ground at the same time as the MR blades during the initial ground contact. Damage to the output shaft key most likely occurred prior to the final ground impact at the accident site that caused boom deformation, separation of the TR driveshaft, and blade damage.

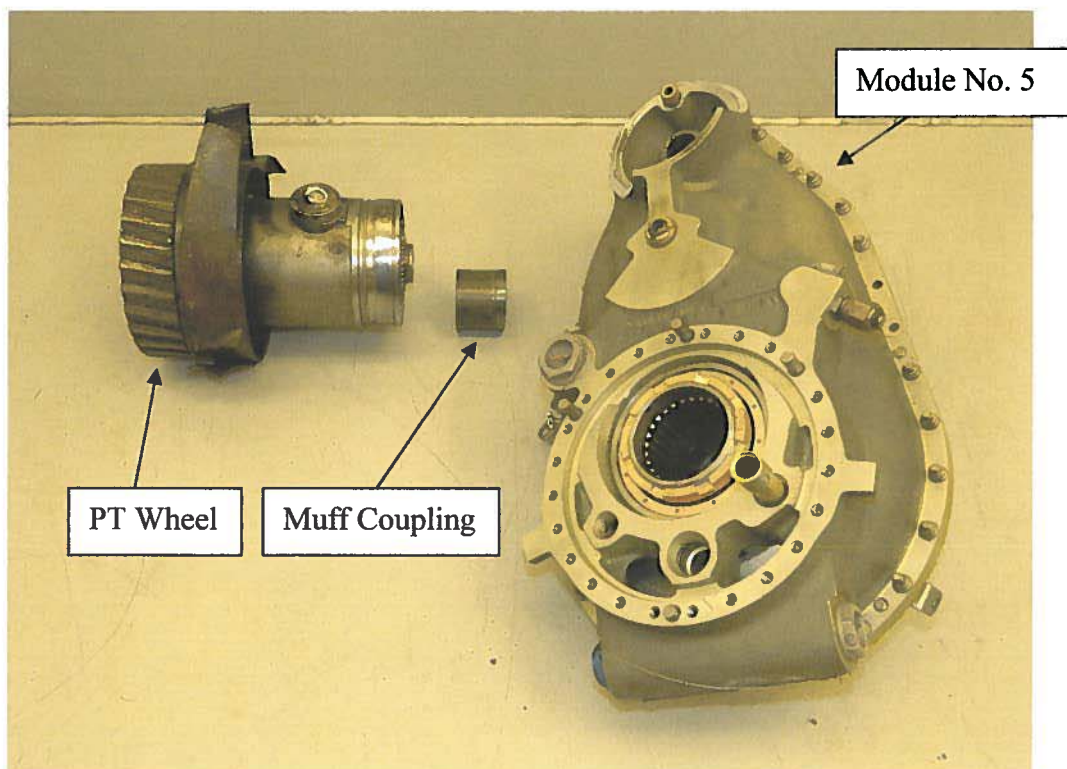
The engine was further disassembled at ASOD and examined on October 24, 2012. Figure 58 shows the PT wheel, muff coupling, and module No. 5 gearbox. Figure 59 shows the PT disk and blade root segments. Fracture of the blades occurred due to

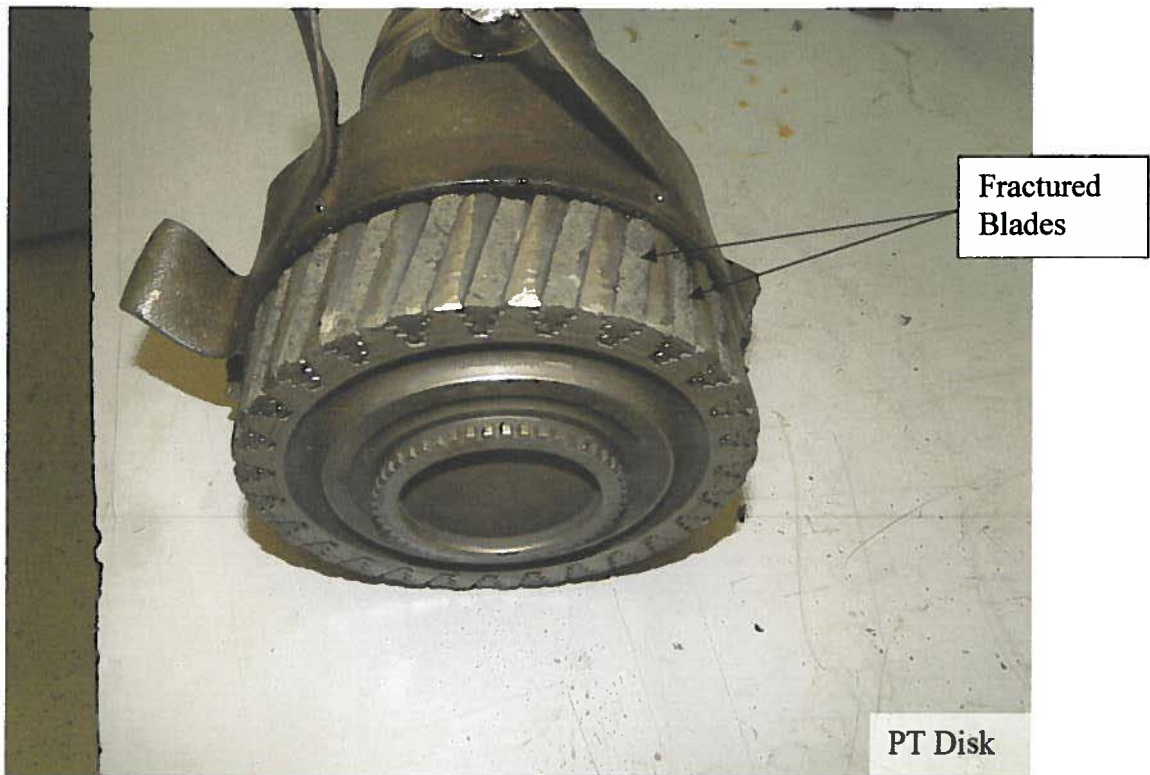
Figure 59

overload forces caused by engine over speed. Multiple impacts were present on the PT containment ring and exhaust duct due to shedding of the blades. The drive retaining nut was over rotated by approximately 7 mm as indicated by the misaligned index marks (Figure 60). Over rotation of the nut occurred when the MR blades impacted the terrain prior to the final crash site causing a severe resistance to rotation. The engine power provided the necessary overload torque required to over rotate the nut during MR blade impact. Impact of the MR blades also caused the muff coupling between the PT wheel and input to the gearbox to deform outward and developed cracks at both ends (Figure 61). The outward flare caused partial loss of spline engagement and eventual damage to the coupling splines (Figure 62) and the PT shaft splines (Figure 63). The same MR blade impacts that caused the engine-to-MGB driveshaft to deform due to overload torsional forces also caused the drive retaining nut to over tighten and the muff coupling to deform. The engine had to have been producing substantial power in order to cause this damage. Engine over speed occurred when the load from the MGB and MR blades was eliminated due to disengagement of the engine-to-MGB driveshaft. Torsional deformation to the PT nozzle housing (bearing support assembly) also is consistent with a severe torque due to MR blade strike. These damage areas had to occur prior to the shedding of the PT blades, which would cause loss of rotational power to the gearbox. If the FFCL was moved initially during flight to the forward emergency position with a functioning FCU, engine over speed and blade shedding would not have occurred because the rotors would have been loaded.

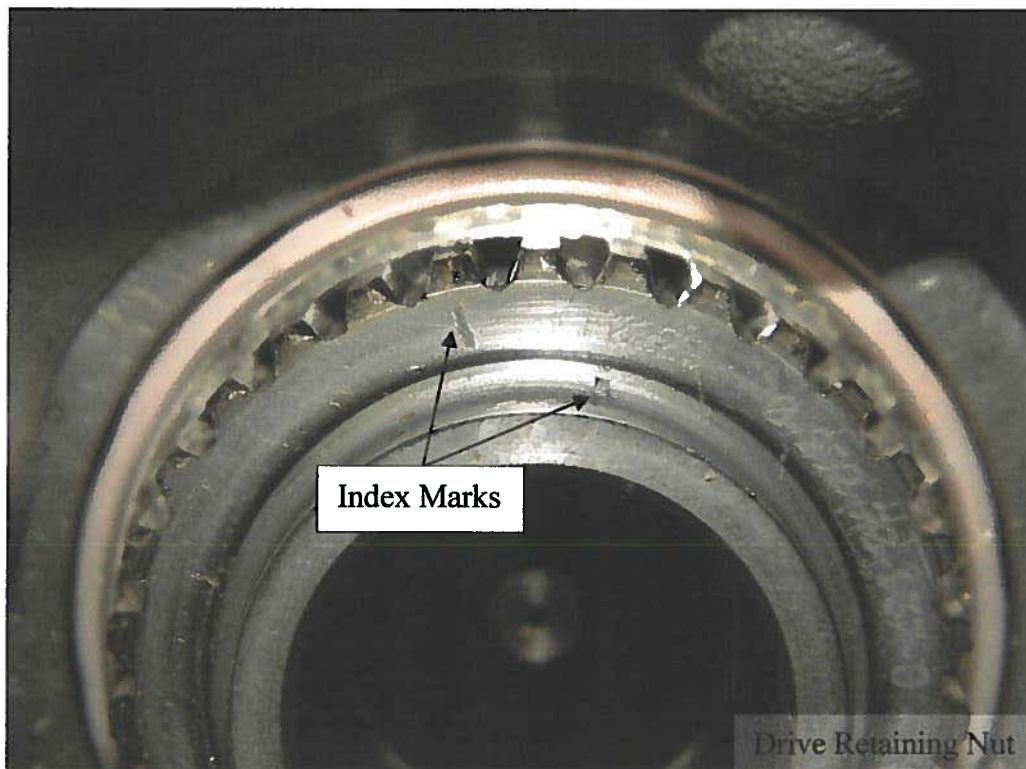
Figure 60

- The engine drive retaining nut in Module No. 5 was over rotated by 7 mm due to an excessive applied torque (estimated to be 500%) while the engine was running. The PT can apply the excessive torque only if the MR blades impact the terrain causing substantial resistance to rotation. Similarly, deformation to the muff coupling indicates that excessive torque was applied to the nut during MR blade impact with the terrain.

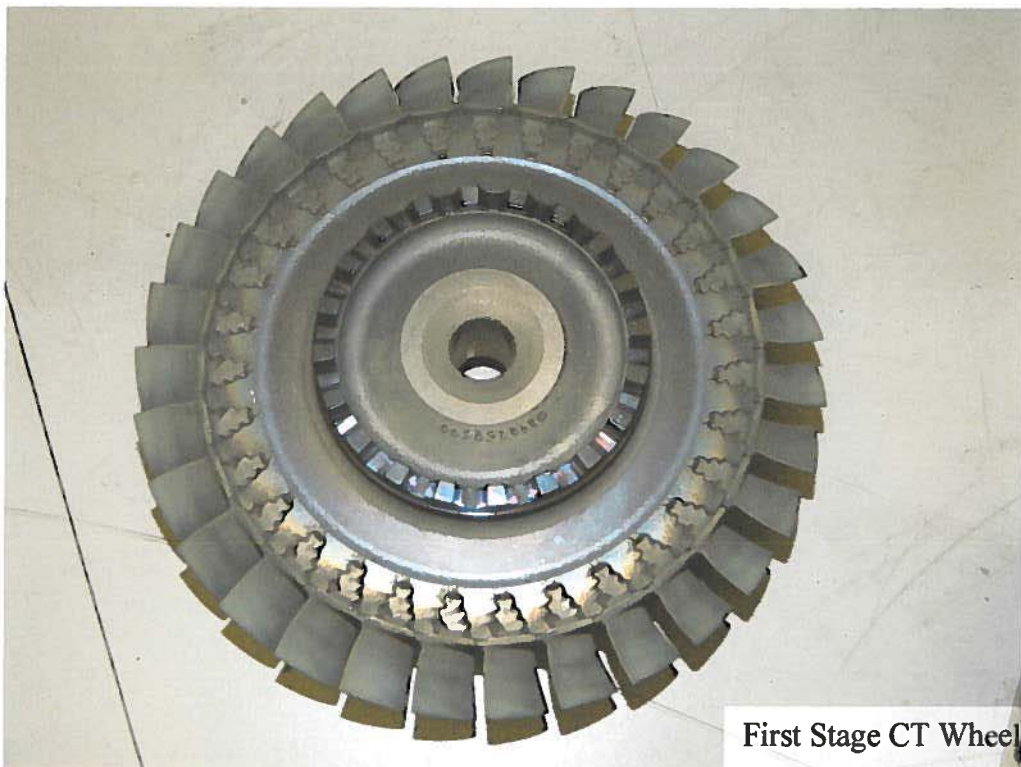
Figure 64

Figures 64 and 65 show the first and second stage CT gas generator wheels, respectively. The blades did not exhibit evidence of overheating. Metal splatters were on the inlet nozzle vanes (Figure 66) and CT wheels (Figure 67). The metal splatters occurred due to rubbing of the compressor axial blades and impeller (Figure 68) during engine operation, most likely when the PT wheel lost its blades. The CT wheels also exhibited minor blade tip rub.

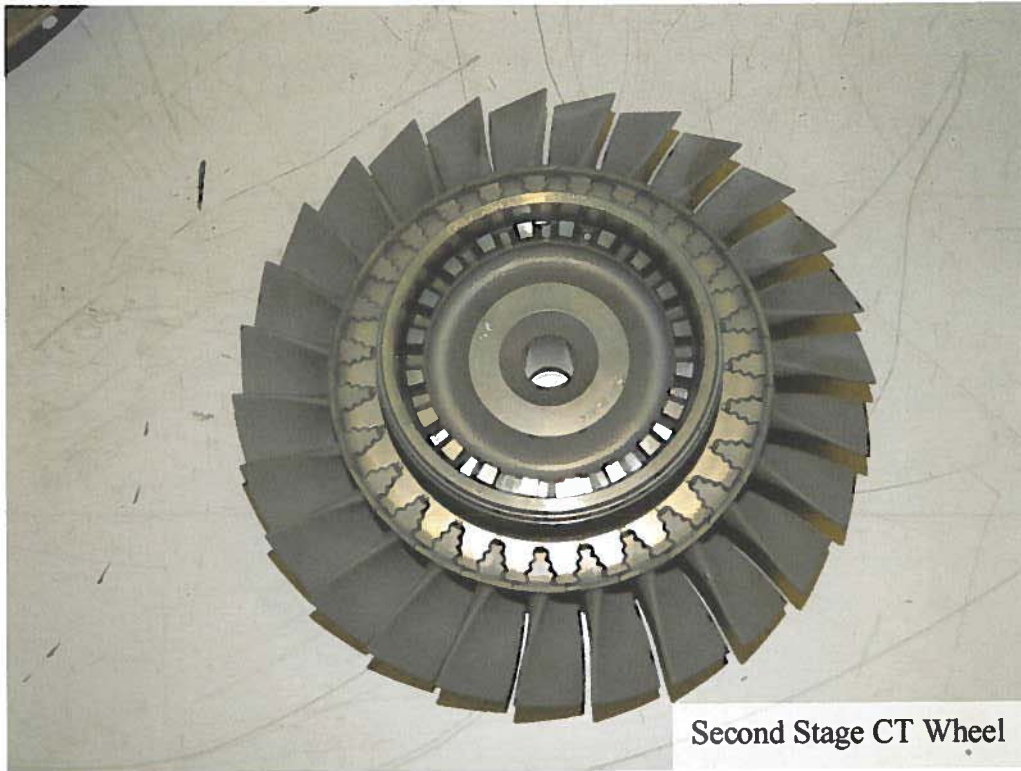
Figure 65

Second Stage CT Wheel

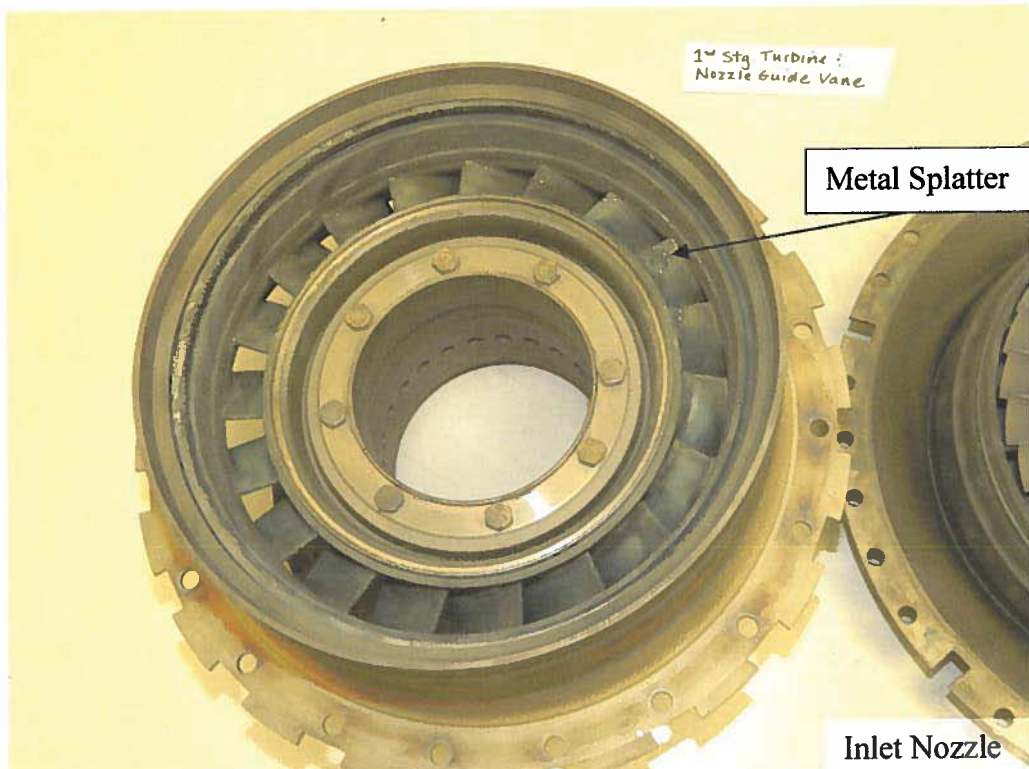
Figure 66

1st Stg Turbine :
Nozzle Guide Vane

Metal Splatter

Inlet Nozzle
